New FAA regulations require towers under 200' to be marked

July 8, 2019 by General Aviation News Staff

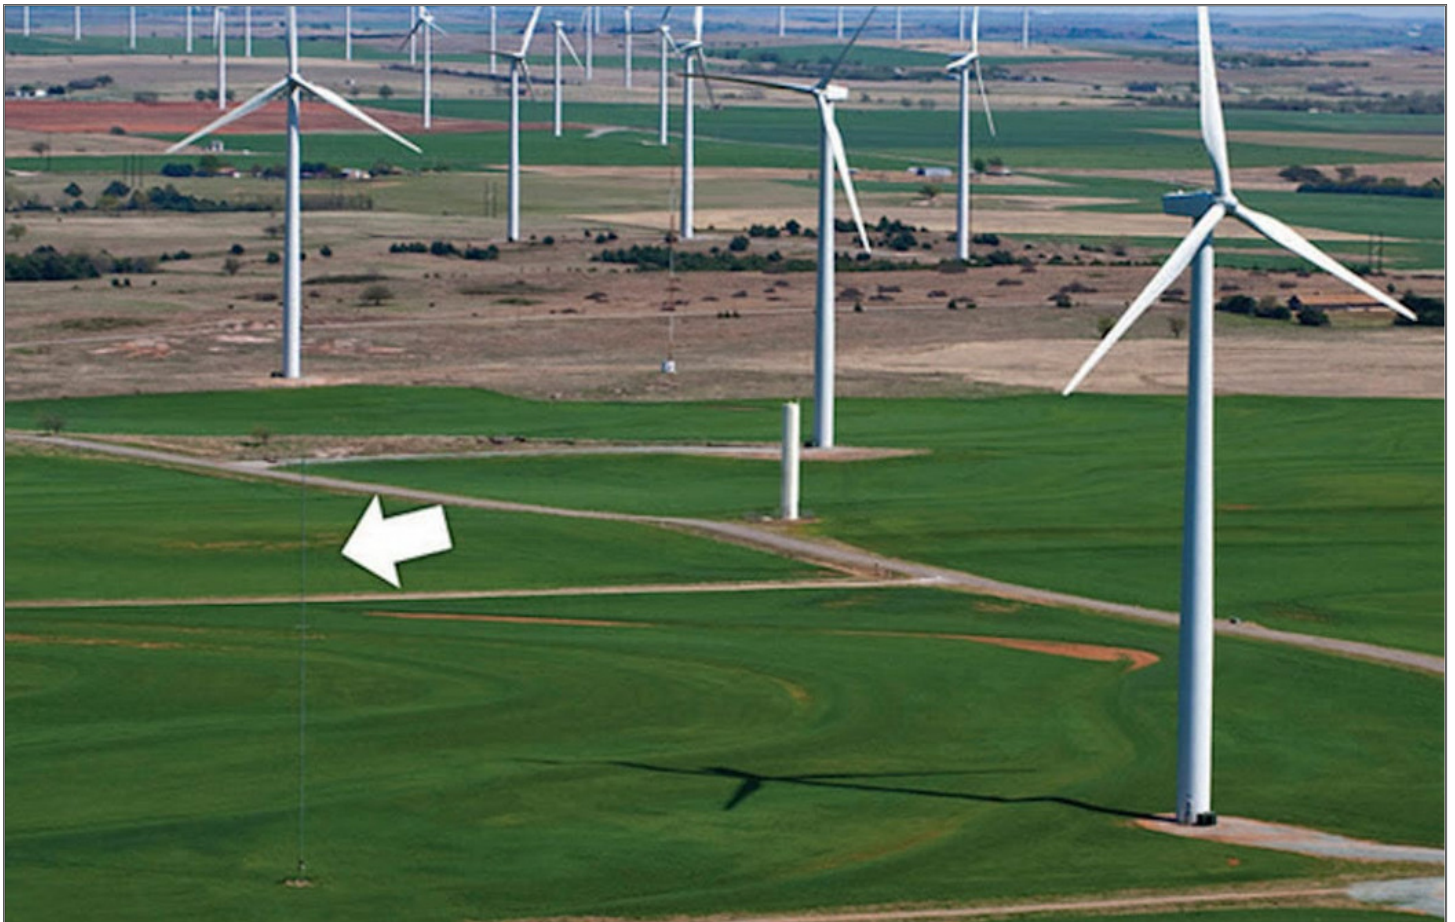
Unmarked meteorological evaluation towers must now be marked under new federal requirements. The arrow points out the almost invisible guy wires that pose such a risk to general aviation pilots.

An NAAA analysis of accidents from 2008 to 2018 across all sectors of general aviation found there were 40 tower-related accidents and incidents resulting in 36 fatalities. The data also shows many of those general aviation aviators did not collide with the main body of the obstruction itself, but the extremely difficult to see guy wires supporting the structure, illustrating the importance of installing high-visibility guy wire sleeves or spherical ball markers, officials said.
